ENERGY AUDIT REPORT

2022-23

Dr. K. N. Modi Institute of Engineering and Technology

Modi Nagar, Ghaziabad (Uttar Pradesh)

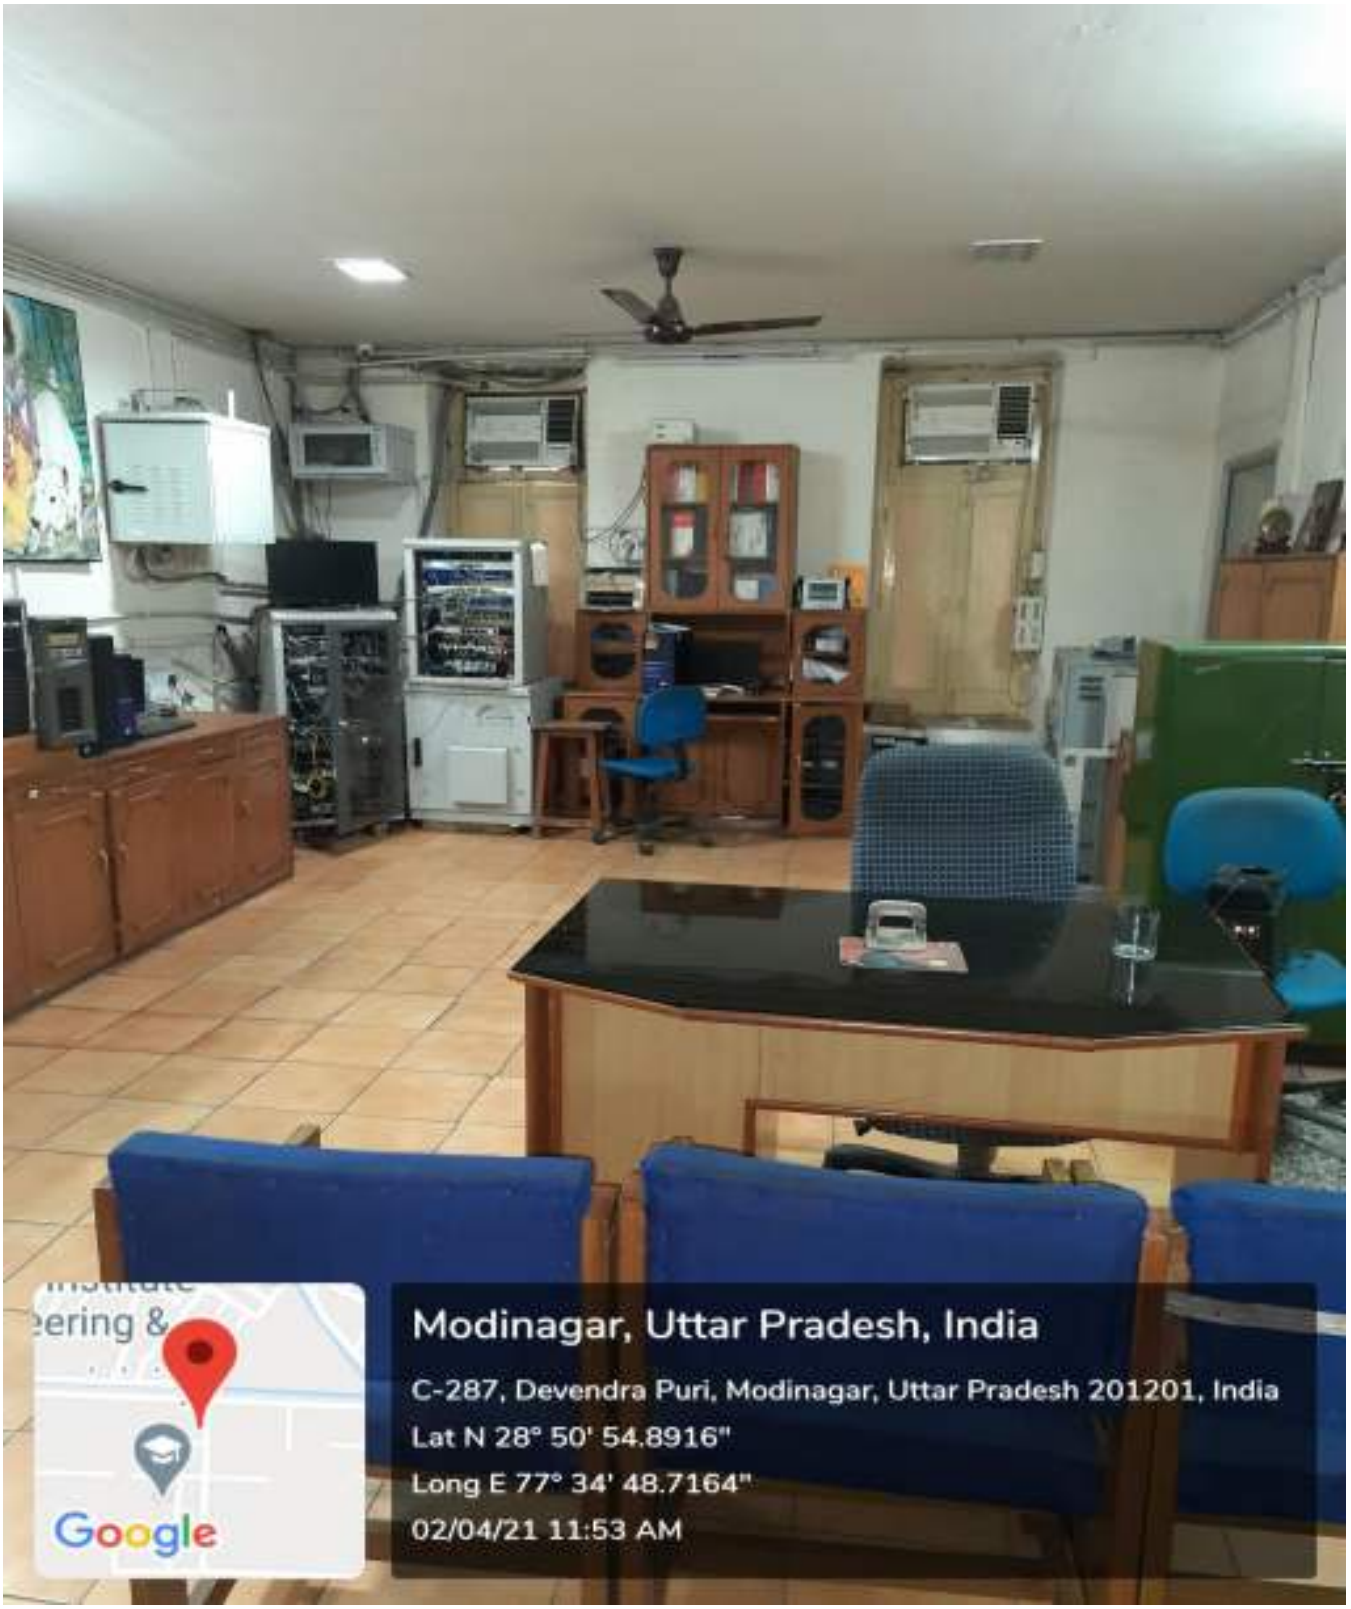
Fig: In this photo, no regulator is found.

(vii) At present, all the ceiling Fans are running without regulator, this practice should be avoided and it is suggested to run the fans with proper regulators or use star rated energy efficient Ceiling Fans.
